## Annual Inspection Report

**Kernow Crescent Play Area**

<b>Client:</b>	Campbell Park Parish Council
<b>Address:</b>	1 Pencarrow Place Fishermead Milton Keynes MK6 2AS
<b>Date:</b>	22nd May 2025
<b>Inspector:</b>	Peter Briggs

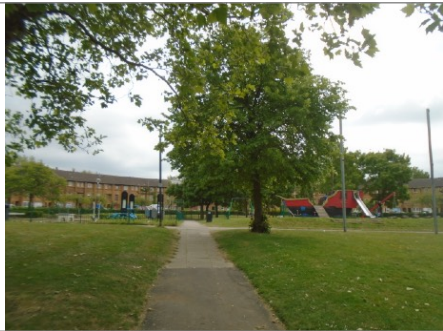
Uneven pathway in places. Possible trip hazard.

Damaged bow top fencing.

Worn paintwork to benches evident.

Old tree stump evident in seating area. Possible trip/slip hazard.

Trip hazard to various seating areas.

**Recommendation:**  
Repair as required.

**Recommendation:**  
Monitor this condition.

**Recommendation:**  
Repaint as necessary.

**Recommendation:**  
Remove stump(s).

**Recommendation:**  
Improve to flush condition.

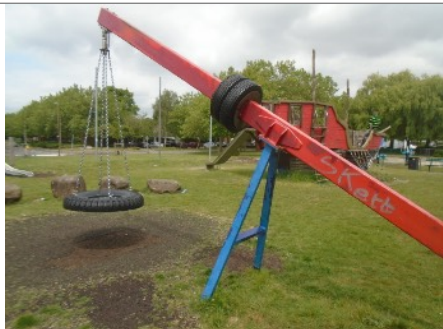
Possible wear to universal joint and chains/bearings.

**Recommendation:**  
Investigate this area following recommended inspection/  
maintenance scheduling from the manufacturer.

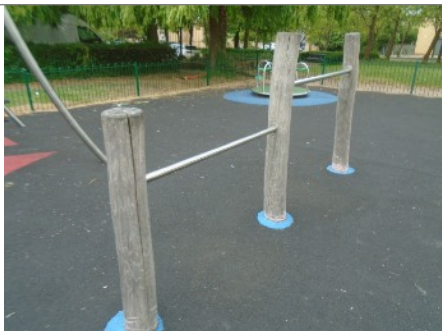
Splits/cracks evident to posts.

**Recommendation:**  
Monitor to remove any sharp edges.

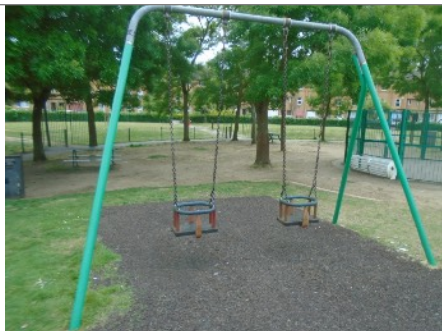
Worn chains evident.

"D" shackle/bushes worn.

**Recommendation:**  
Monitor to replace at 40% diameter of wear asap.

**Recommendation:**  
Investigate to replace item(s) as required.

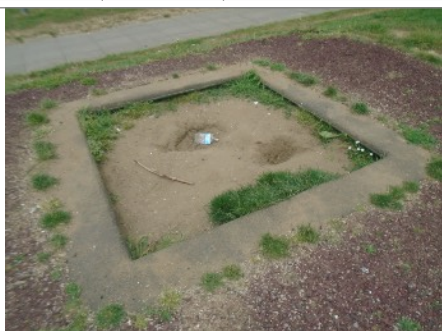
Missing trampoline pad evident.

**Recommendation:**  
Consider removing item, item infilled with more soil.

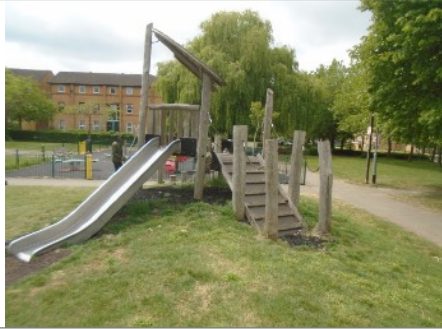
Cracks/splits evident to most posts.

**Recommendation:**  
Monitor this condition and refer back to manufacturer for comment if necessary.

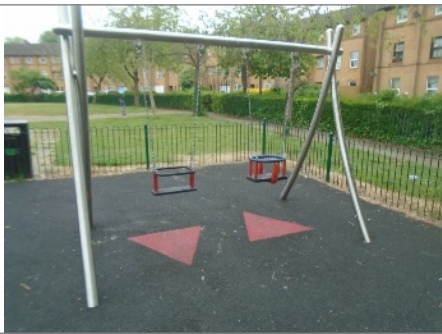
Broken/missing crutch strap.

Chain/connecting link(s) wear evident.

**Recommendation:**  
Replace as required **asap**.

**Recommendation:**  
Monitor to replace at 40% dia wear.

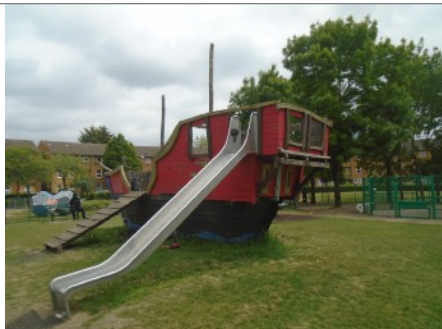
Most areas of timber appear to show evidence of splits/decay in places.

**Recommendation:**  
Repair or remove item from use asap.

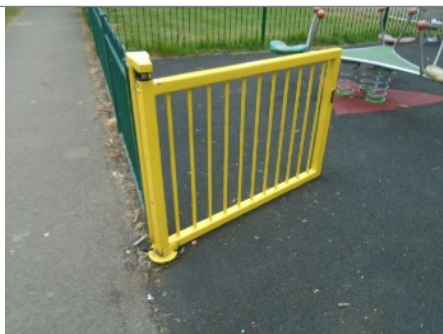
Worn surface and bricks evident on site.

**Recommendation:**  
Adjust closing mechanism to operate between 4-8 seconds from a 90 degree position.

**Recommendation:**  
Repair surface and remove bricks.

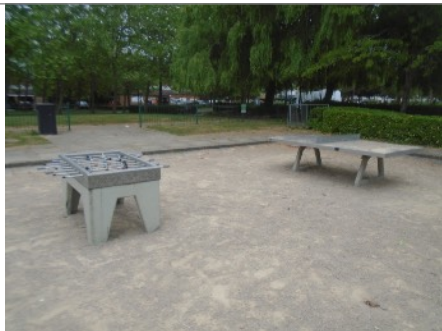
Uneven trip hazard on tarmac. Poor condition of area.

Damaged surrounding surface and steps.

**Recommendation:**  
Repair as required **asap.**

**Recommendation:**  
Repair as necessary **asap.**

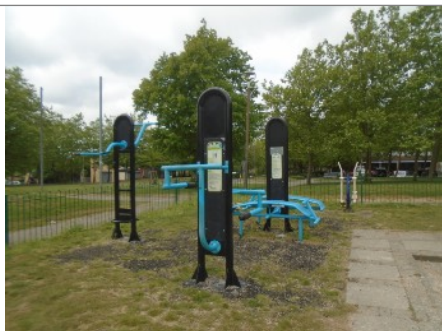
Rust/corrosion evident in some areas.

Signage missing on some items.

**Recommendation:**  
Monitor to rub down and repaint as required.

**Recommendation:**  
Replace as required.

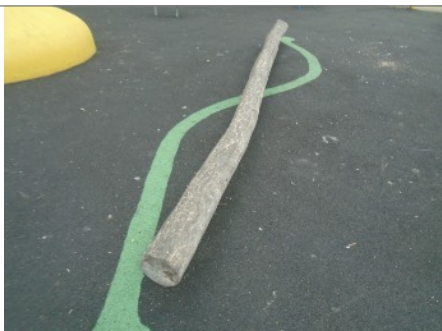
Splits/cracks and decay evident in wooden posts.

**Recommendation:**  
Monitor this condition & keep free from sharp edges.

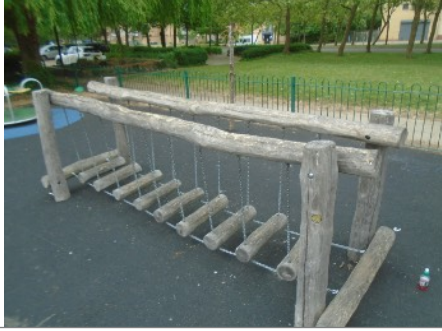
Splits/cracks and decay evident in wooden posts.

**Recommendation:**  
Monitor this condition & keep free from sharp edges.
