**12. Kernow Crescent Play Park Annual Inspection Report**

Committee is invited to receive, note, and action the independent annual Inspection report of Kernow Crescent play area as carried out by Seagrave Inspection Services Ltd.

## Annual Inspection Report

**Kernow Crescent Play Area**

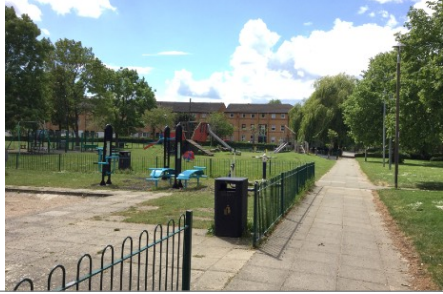
Uneven pathway in places. Possible trip hazard.

Damaged bow top fencing.

Worn paintwork to benches evident.

**Recommendation:**  
Repair as required.

**Recommendation:**  
Monitor this condition.

**Recommendation:**  
Repaint as necessary.

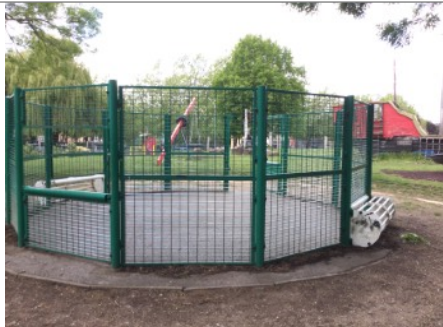
No faults found during the inspection.

**Recommendation:**  
No action required, monitor this area.

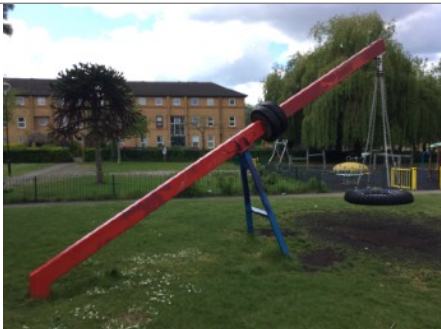
Possible wear to universal joint and chains/bearings.

Slight chain/connecting link(s) wear evident.

**Recommendation:**  
Investigate this area following recommended inspection/  
maintenance scheduling from the manufacturer.

**Recommendation:**  
Monitor to replace at 40% dia wear.

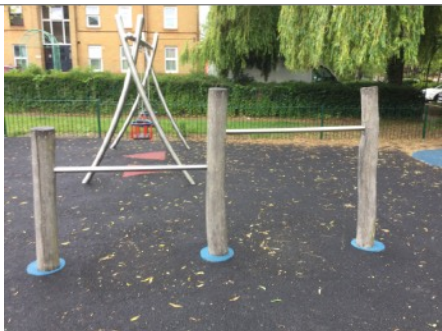
Splits/cracks and decay evident in wooden posts.

**Recommendation:**  
Monitor this condition & keep free from sharp edges.

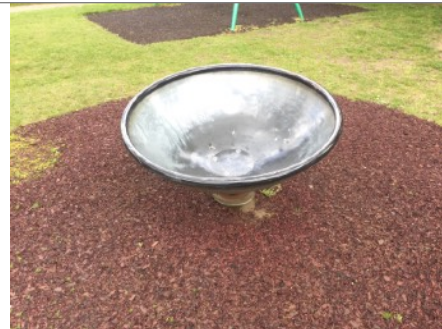
No faults found during the inspection.

**Recommendation:**  
No action required, monitor this item.

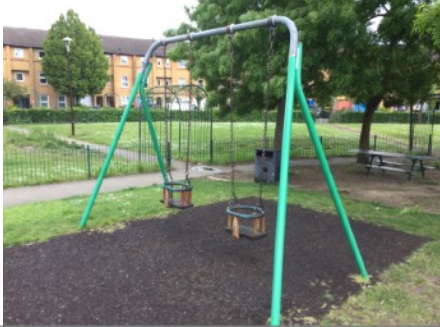
Worn chains evident.

**Recommendation:**  
Monitor to replace at 40% diameter of wear asap.

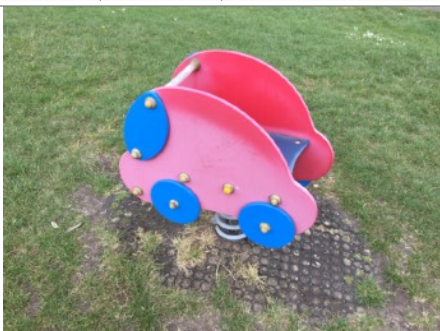
No faults found during the inspection.

**Recommendation:**  
No action required, monitor this item.

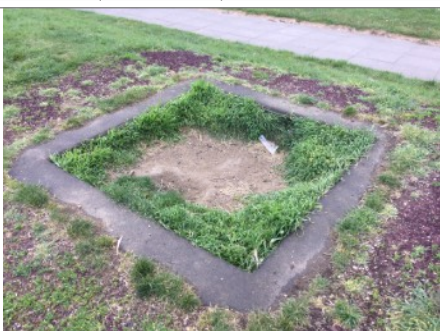
Missing trampoline pad evident.

**Recommendation:**  
Consider removing item, item infilled with soil.

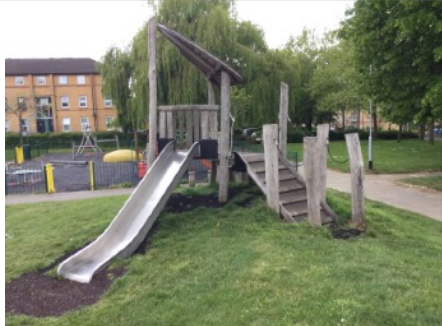
Cracks/splits evident to most posts.

**Recommendation:**  
Monitor this condition and refer back to manufacturer for comment if necessary.

**Recommendation:**  
Remove this condition and refer back to manufacturer for comment if necessary.

**Recommendation:**  
Consider to re-stain areas.

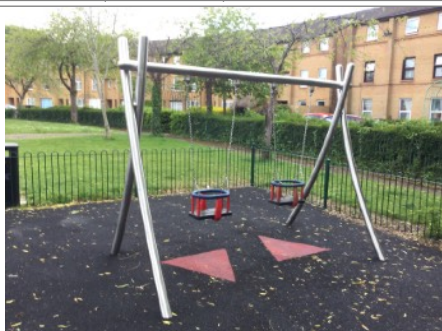
Chain/connecting link(s) wear evident.

**Recommendation:**  
Monitor this condition.

**Recommendation:**  
Monitor to replace at 40% dia wear.

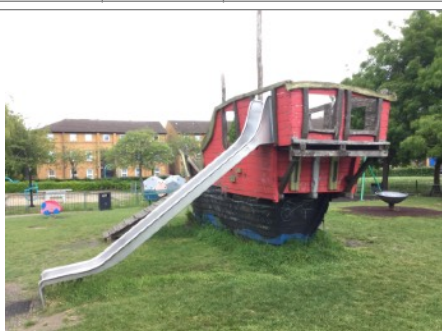
Most areas of unit showing signs of decay with large splits & protruding fixings.

Damaged ladder fixing.  
**Recommendation:**  
As above.

**Recommendation:**  
Repair/replace areas asap.

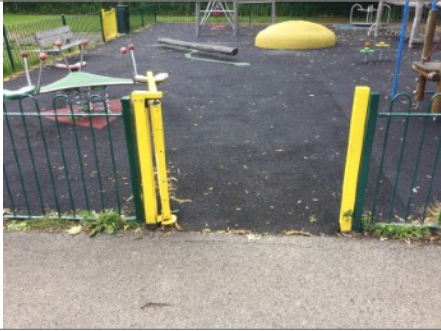
| <b>Item</b> | Gate | | | | |

Gate closing too slow.  
**Recommendation:**  
Adjust closing mechanism to operate between 4-8 seconds from a 90 degree position.

Gate post loose in ground fixing.  
**Recommendation:**  
Monitor to repair this condition.

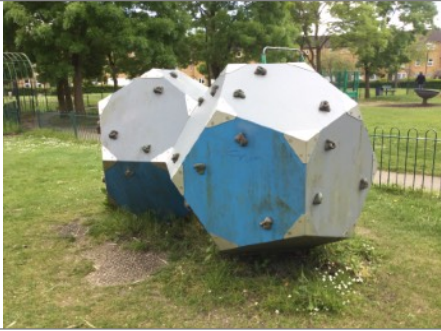
| <b>Item</b> | Bloxx Climbers x 2 | | | | |

Worn/poor surface evident.  
**Recommendation:**  
Carry our improvements to surfacing.

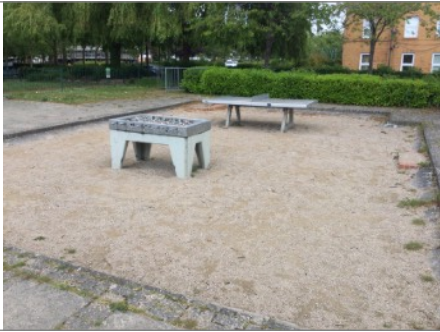
Uneven trip hazard on tarmac.

**Recommendation:**  
Repair as required **asap.**

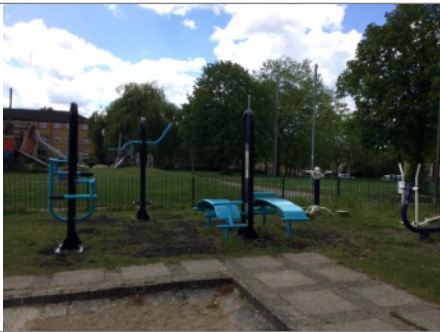
Rust/corrosion evident in some areas.

Signage missing on some items.

**Recommendation:**  
Monitor to rub down and repaint as required.

**Recommendation:**  
Replace as required.

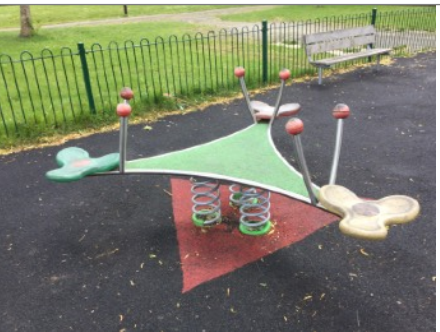
No faults found during the inspection.

**Recommendation:**  
No action required, monitor this item.

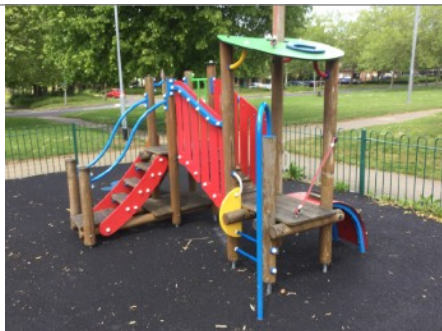
Slight decay evident.  
**Recommendation:**  
Monitor for deterioration.

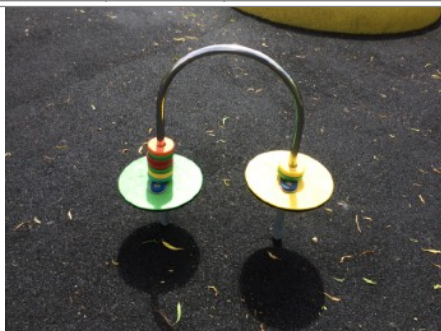
No faults found during the inspection.  
**Recommendation:**  
No action required, monitor this item.

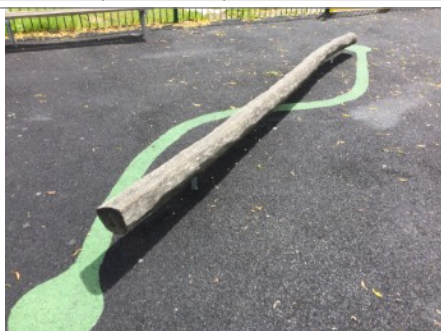
Splits/cracks and decay evident in wooden posts.  
**Recommendation:**  
Monitor this condition & keep free from sharp edges.

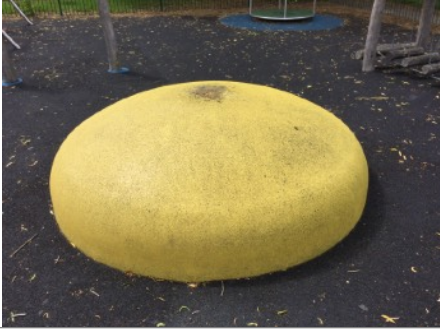
Slight damage evident to top of unit.

**Recommendation:**  
Monitor this condition.

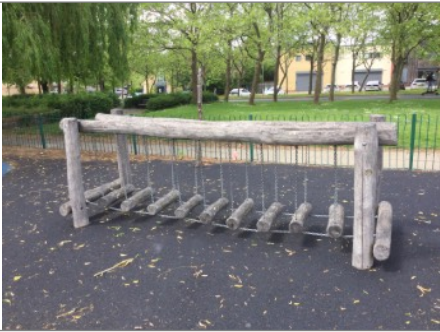
Splits/cracks and decay evident in wooden posts.

Chain/connecting link(s) wear evident.

**Recommendation:**  
Monitor this condition & keep free from sharp edges.

**Recommendation:**  
Monitor to replace at 40% dia wear.

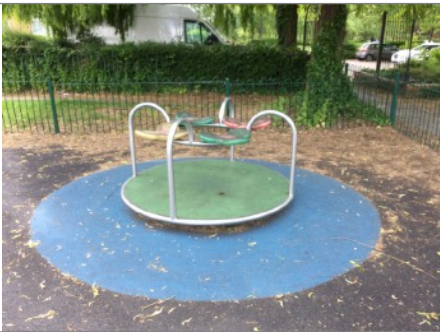
No faults found during the inspection.

**Recommendation:**  
No action required, monitor this item.
